# Manhole Inspection Summary

Manhole # S45C\_\_057MH

Insp Date: **8/15/08 9:19 AM**

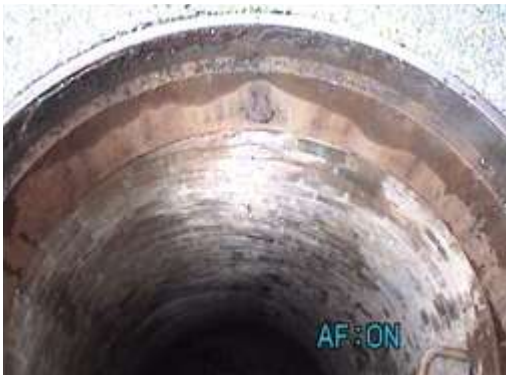
Defect 2

☒ **Leaks**

Frame leaks

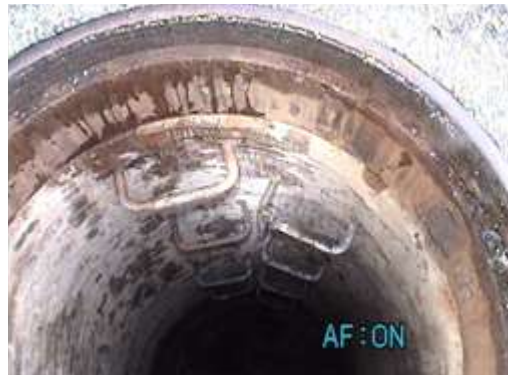
Defect 1

Infiltration: ☐ None ☐ Joint ☐ Cracks ☐ Mortar ☐ Roots ☒ **Wall**

Infiltration

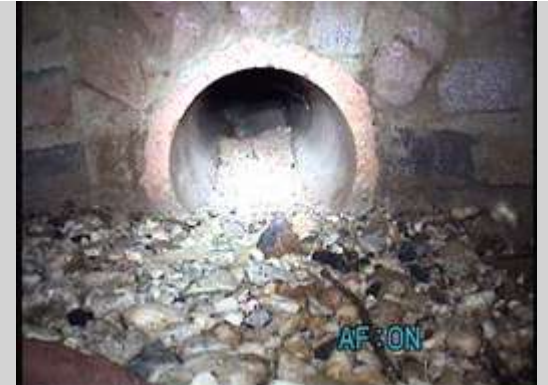
12 O'Clock Outflow

8 in. Circular Gravity Sewer  
Pipe Out @ 12 O'Clock

Deposits: ☐ None ☐ Mud ☐ Sludge ☒ **Debris** ☐ Grease

Silt Depth: **0.15** (in.) Deposits Extent: **Light**
